Technical Report CHL-99-7  
April 1999

# **Dam Safety Assurance Model Study of Tygart Dam, Tygart River, Grafton, West Virginia**

U.S. Army Corps of Engineers  
Waterways Experiment Station  
3909 Halls Ferry Road  
Vicksburg, MS 39180-6199

Prepared for U.S. Army Engineer District, Pittsburgh  
Pittsburgh, PA 15222-4186

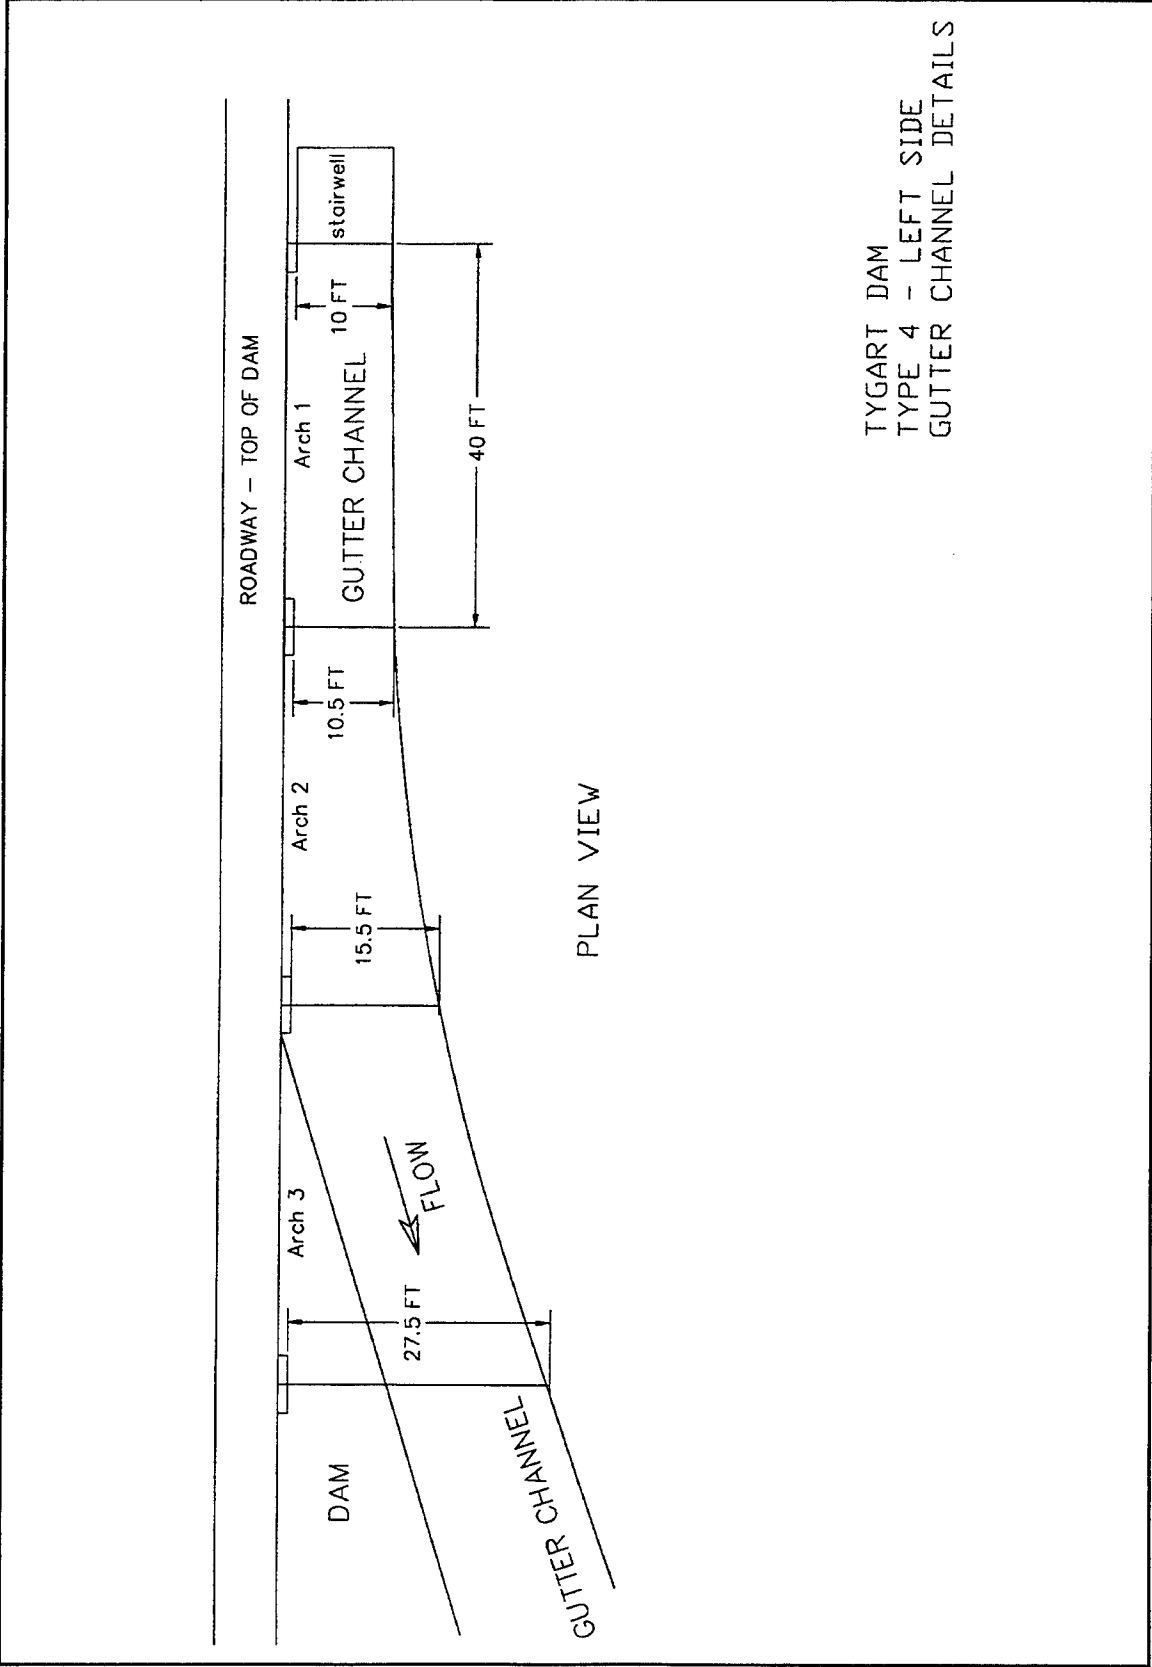
TYGART DAM  
 TYPE 4 - LEFT SIDE  
 GUTTER CHANNEL DETAILS
